# TEST REPORT

## MAGNETIC PARTICLE TESTING (MT)

Project Title : **BJT PROJECT**

Description : Brackets Steel Weld Joints (GFRC Panel Frame)

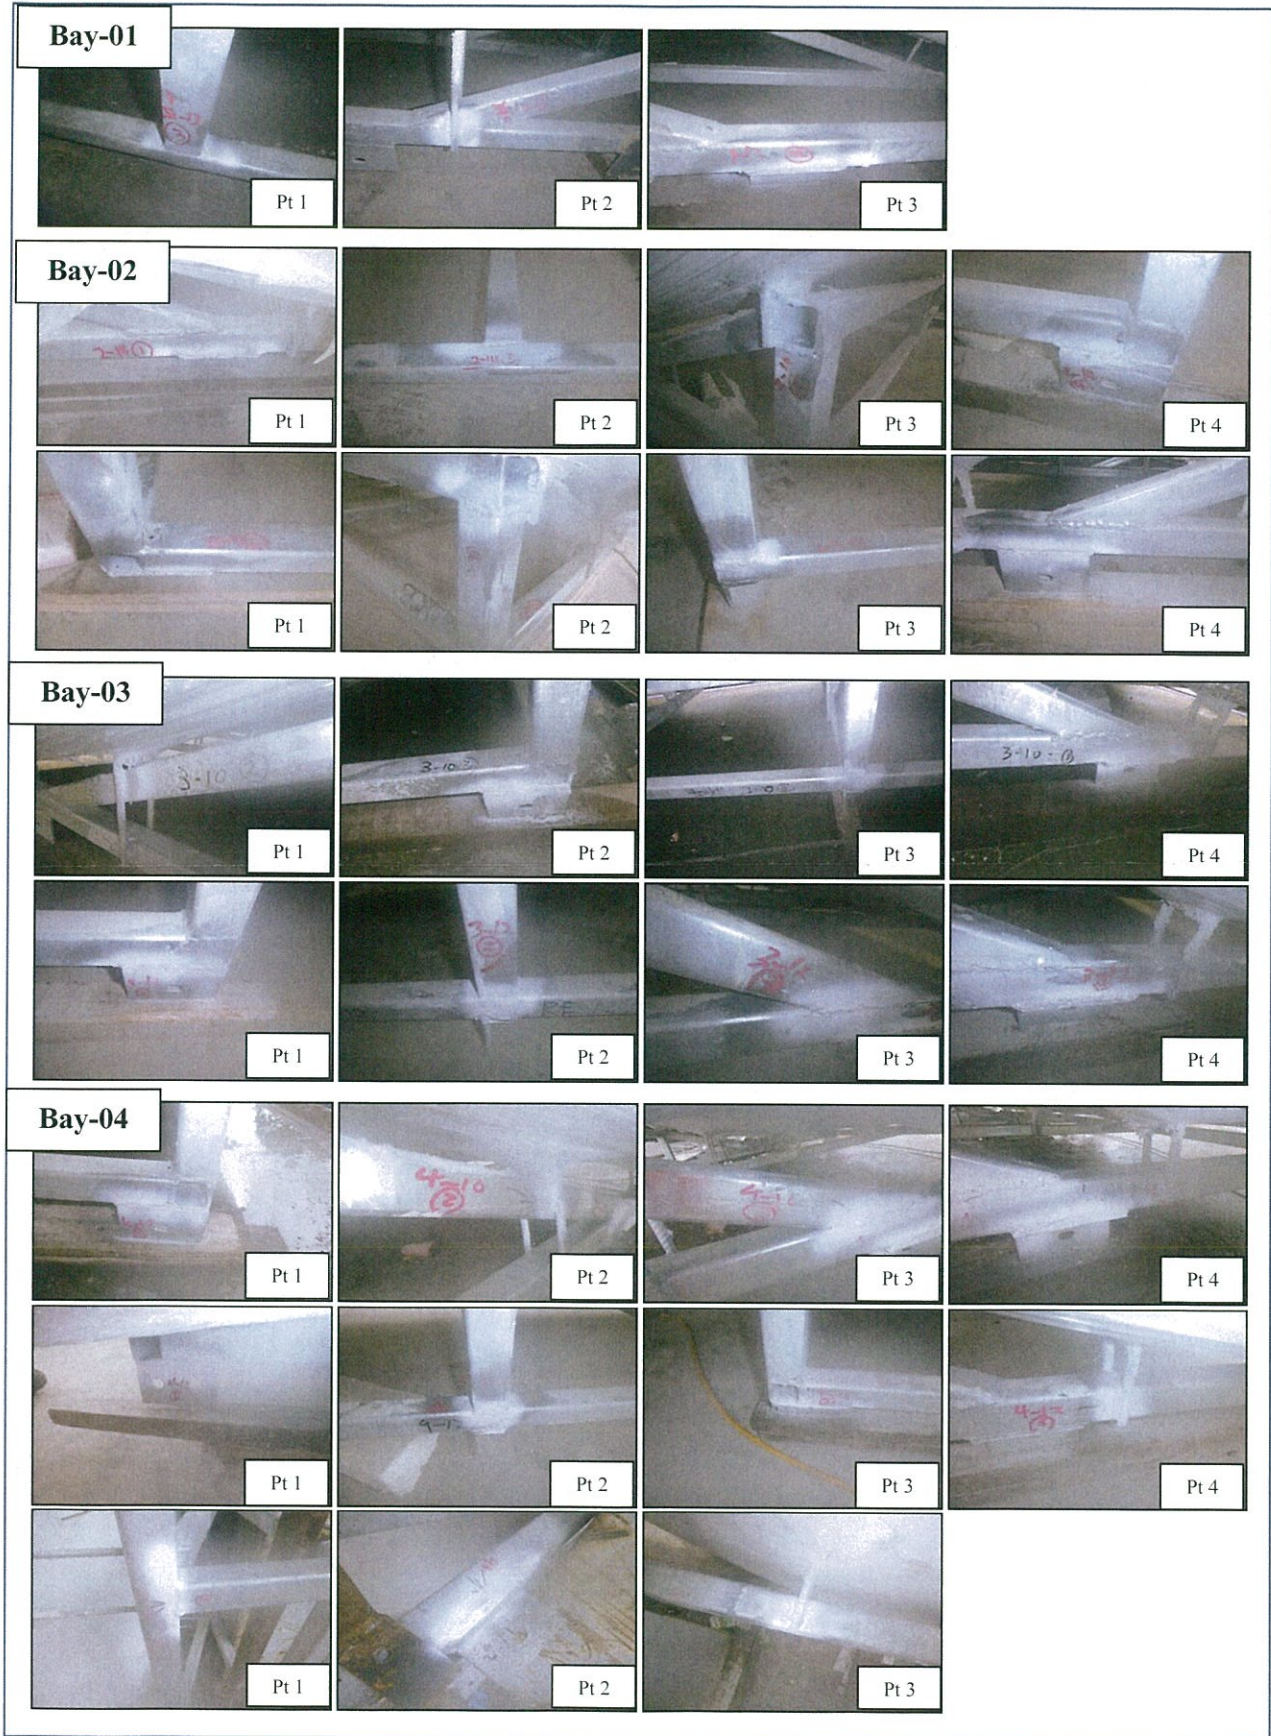
**PHOTOS ATTACHED**

No.	Weld Identification	Tested Length (mm)	Evaluation			Results	Remarks
			Distance from Datum (mm)	Discontinuity Length (mm)	Discontinuity Type		
#	Brackets Steel Weld Joints (GFRC Panel Frame)						
1	BAY-1						
	Mark No. 1-13 (Jt 1 to Jt 3)	-	-	-	A	S	Refer to photos
2	BAY-2						
	Mark No. 2-14 (Jt 1 to Jt 4)	-	-	-	A	S	Refer to photos
	Mark No. 2-9 (Jt 1 to Jt 4)	-	-	-	A	S	Refer to photos
3	BAY-3						
	Mark No. 3-10 (Jt 1 to Jt 4)	-	-	-	A	S	Refer to photos
	Mark No. 3-12 (Jt 1 to Jt 4)	-	-	-	A	S	Refer to photos
4	BAY-4						
	Mark No. 4-10 (Jt 1 to Jt 4)	-	-	-	A	S	Refer to photos
	Mark No. 4-12 (Jt 1 to Jt 4)	-	-	-	A	S	Refer to photos
	Mark No. 4-13 (Jt 1 to Jt 3)	-	-	-	A	S	Refer to photos
	Note: The above item tested was carried on accessible area only.
