TEST REPORT

MAGNETIC PARTICLE TESTING (MT)

Project Title : BJT PROJECT
Date of Test : 07 July 2021
Location of Test : 38, Joo Koon Road

Description : Steel Bracket Weld Joints
Material : Carbon Steel
Thickness : 6mm
Type of Weld / Welding Process : Fillet / MMAW

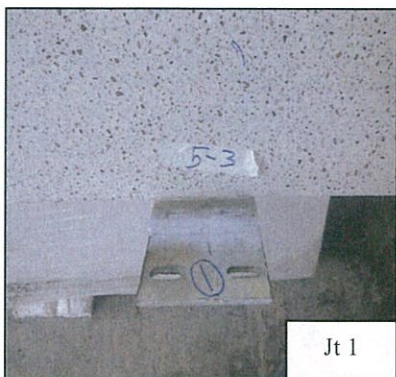
Jt 1

No.	Weld Identification	Tested Length (mm)	Evaluation			Results	Remarks
			Distance from Datum (mm)	Discontinuity Length (mm)	Discontinuity Type		
#	Steel Bracket Weld Joints						
1.	Bracket No.: 5-3 (Jt 1)	-	-	-	A	S	Refer to photos
2.	Bracket No.: 5-1 (Jt 2)	-	-	-	A	S	Refer to photos
3.	Bracket No.: 4-3 (Jt 3)	-	-	-	A	S	Refer to photos
4.	Bracket No.: 4-2 (Jt 4)	-	-	-	A	S	Refer to photos
5.	Bracket No.: 3-4 (Jt 5)	-	-	-	A	S	Refer to photos
6.	Bracket No.: 1-3 (Jt 6)	-	-	-	A	S	Refer to photos
7.	Bracket No.: 1-2 (Jt 7)	-	-	-	A	S	Refer to photos
8.	Bracket No.: 1-1 (Jt 8)	-	-	-	A	S	Refer to photos
9.	Bracket No.: 2-6 (Jt 9)	-	-	-	A	S	Refer to photos
10.	Bracket No.: 5-2 (Jt 10)	-	-	-	A	S	Refer to photos
*	Note: The above item tested was carried on accessible area only.
