# TEST REPORT

## MAGNETIC PARTICLE TESTING (MT)

Project Title : **BJT PROJECT**

Description : Support Steel Frame Weld Joints

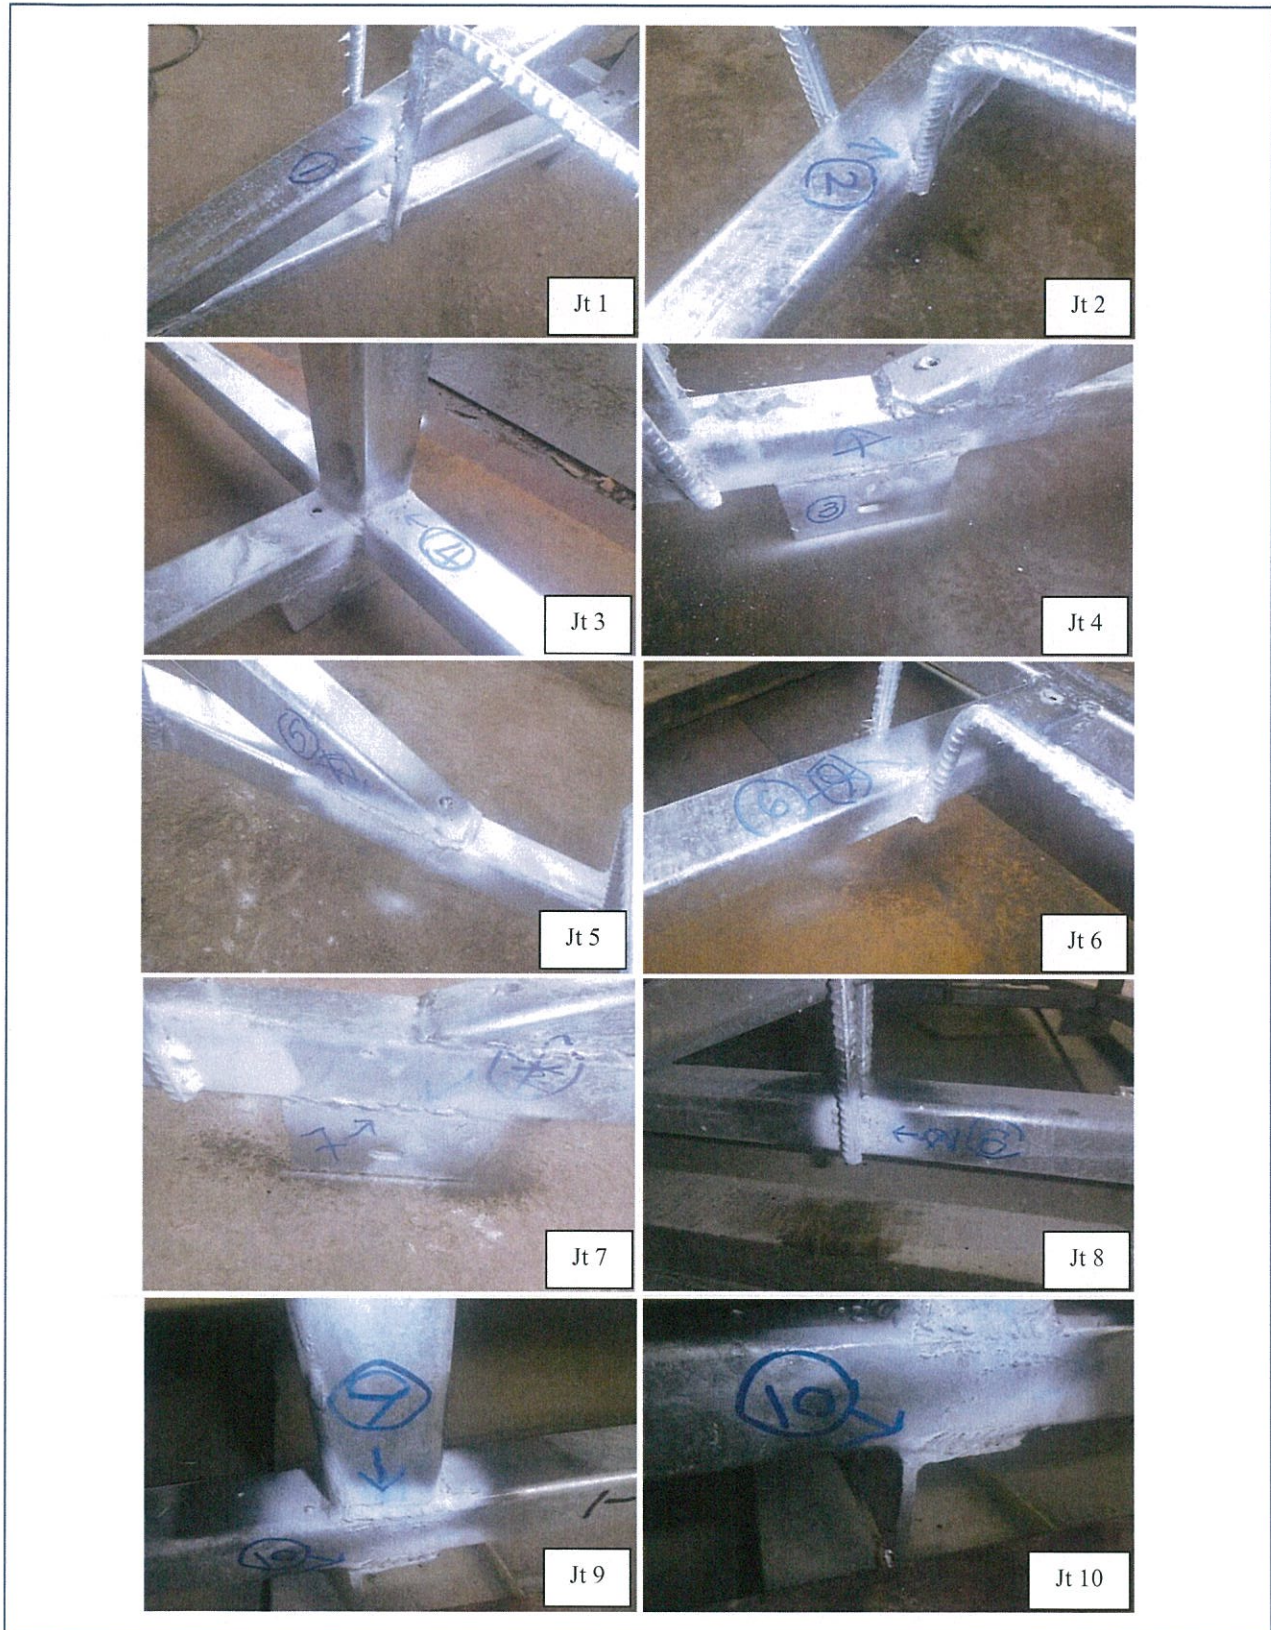
**PHOTOS ATTACHED**

No.	Weld Identification	Tested Length (mm)	Evaluation			Results	Remarks
			Distance from Datum (mm)	Discontinuity Length (mm)	Discontinuity Type		
#	Support Steel Frame Weld Joints						
	Jt 1 to Jt 10 (Total: 10 Joints)	-	-	-	A	S	Refer to photos
Note: The above item tested was carried on accessible area only.
